LIVESTOCK INSPECTION DIGITAL PHOTOGRAPH PHOTOCOPIES

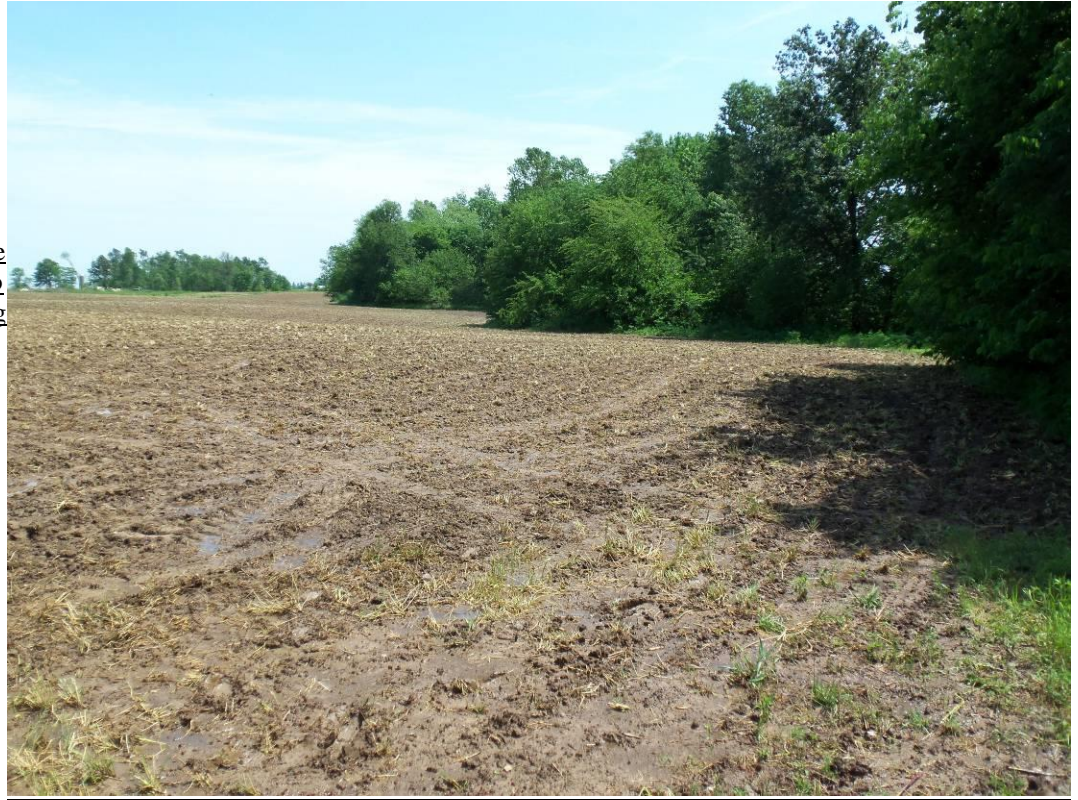
Photo # 001
Date: May 01, 2012
Time: 2:07 p.m.
Taken By: Brian Rodely DWPC/FOS
Facility: VB Family Farms
Location: Application Site Face SE
Notes: Conditions of the land application site where the complainant alleges manure was running into creek. No evidence of manure running from land application field was noted. The field was recently tilled and planted in corn.

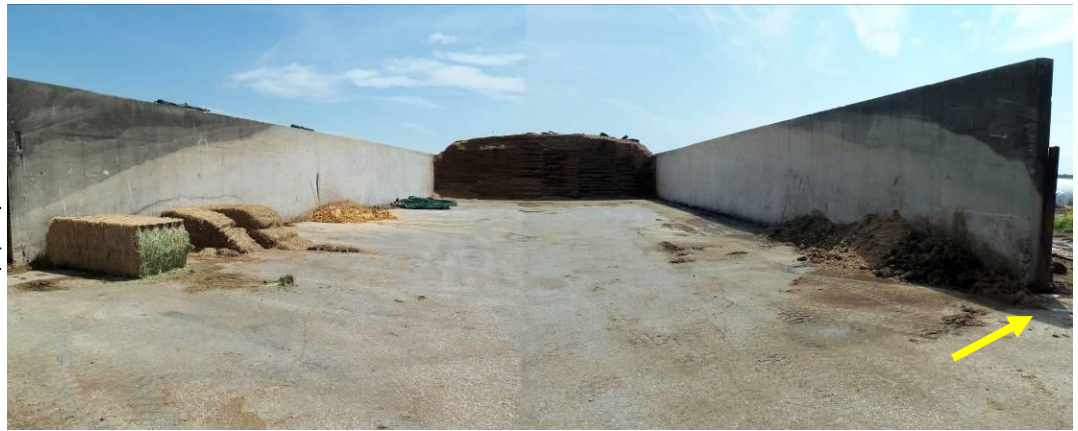
Photo # 002
Date: May 01, 2012
Time: 2:07 p.m.
Taken By: Brian Rodely DWPC/FOS
Facility: VB Family Farms
Location: N Silage Bunker Face S
Notes: Panoramic photo shows the north end of the silage bunker. A small amount of leachate was noted exiting the bunker on the NW corner of the pad as indicated by the yellow arrow.

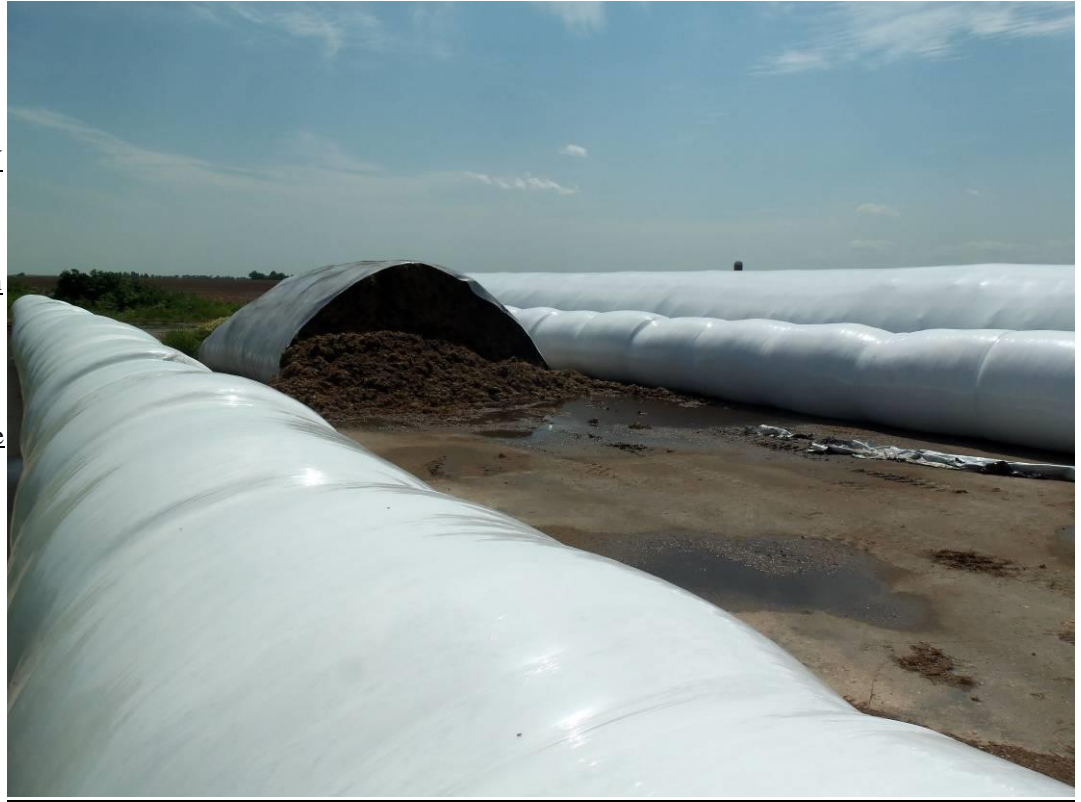
Photo # 003
Date: May 01, 2012
Time: 2:18 p.m.
Taken By: Brian Rodely DWPC/FOS
Facility: VB Family Farms
Location: SW SilageBunker Face SW
Notes: Stored silage and hay is bagged and wrapped as shown in the photo. An open silage bag can be seen in the center of the photo where silage is exposed to precipitation resulting in runoff. Note how clean the pad has been scraped where silage has been used.

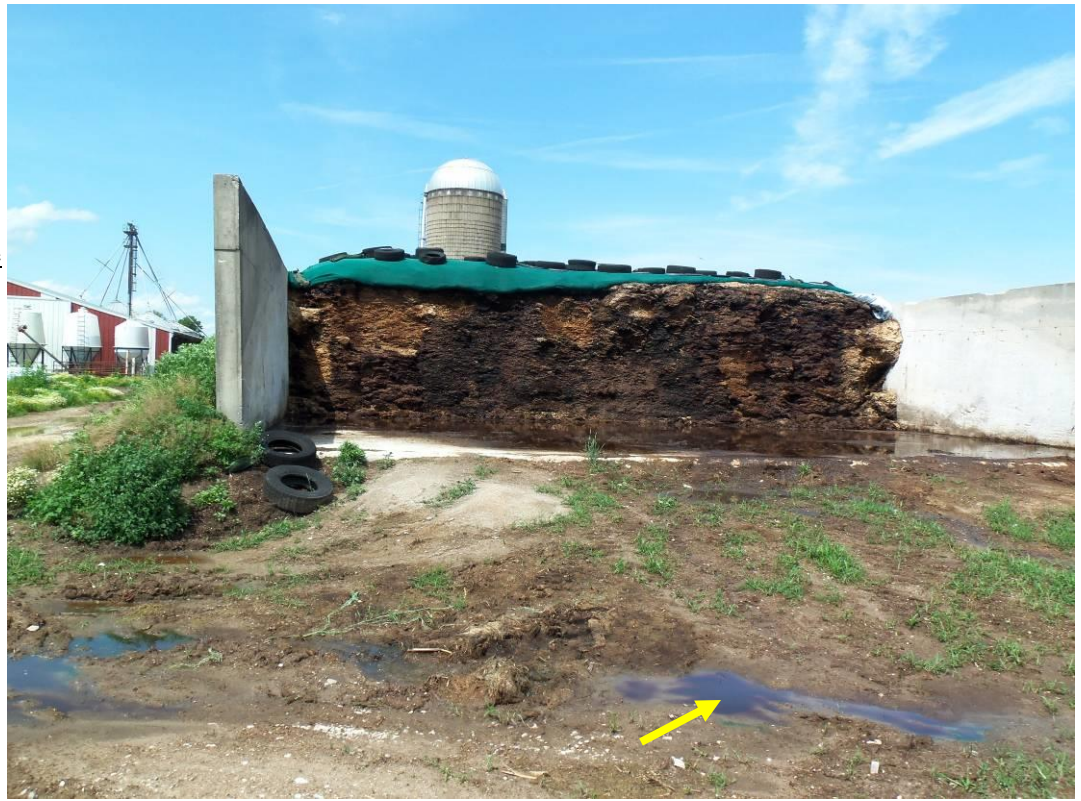
Photo # 004
Date: May 01, 2012
Time: 2:18 p.m.
Taken By: Brian Rodely DWPC/FOS
Facility: VB Family Farms
Location: S Silage Bunker Face N
Notes: Stored silage on the south end of the silage bunker is in standing water. Note the dark nutrient-laden wastewater down gradient of the silage bunker as pointed out by the yellow arrow.

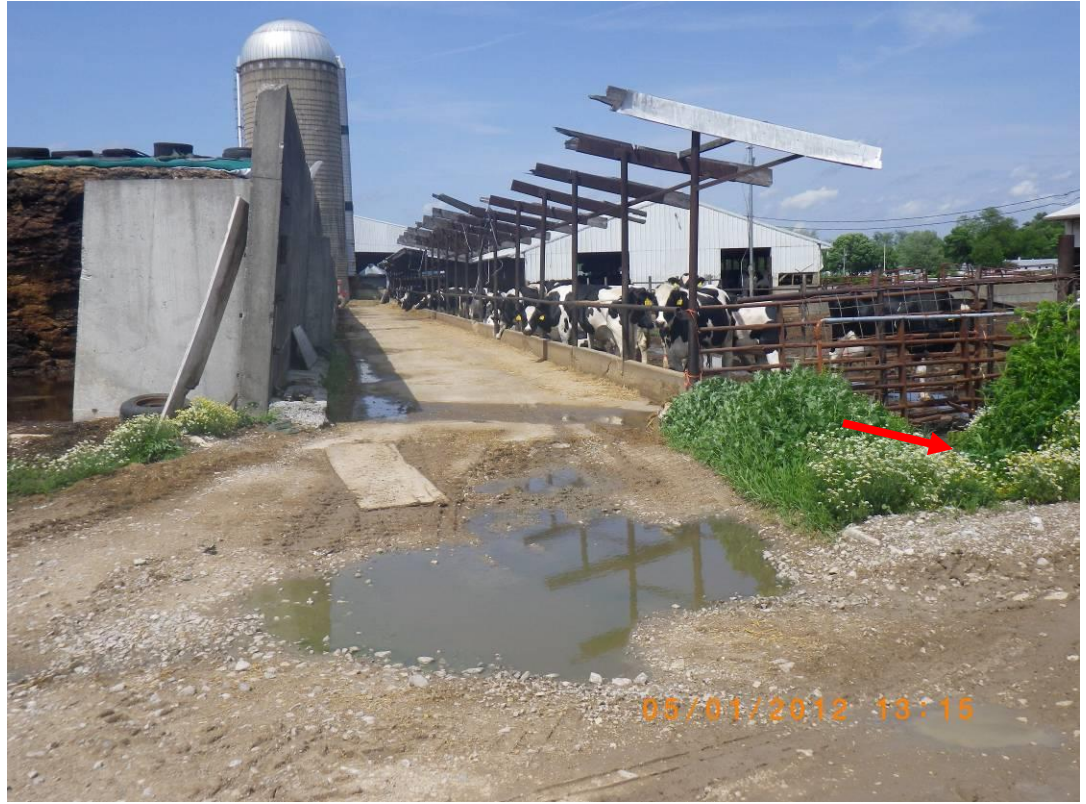
Photo # 005
Date: May 01, 2012
Time: 2:21 p.m.
Taken By: Brian Rodely DWPC/FOS
Facility: VB Family Farms
Location: SE Silage Bunker Face N
Notes: A feed alley is shown next to the silage bunker where the roof is missing to protect feed from precipitation. The feedlot to the right (east) of the feed alley drains to a culvert indicated by the red arrow but concealed by the vegetation. The culvert inlet can be seen in Photo 006.

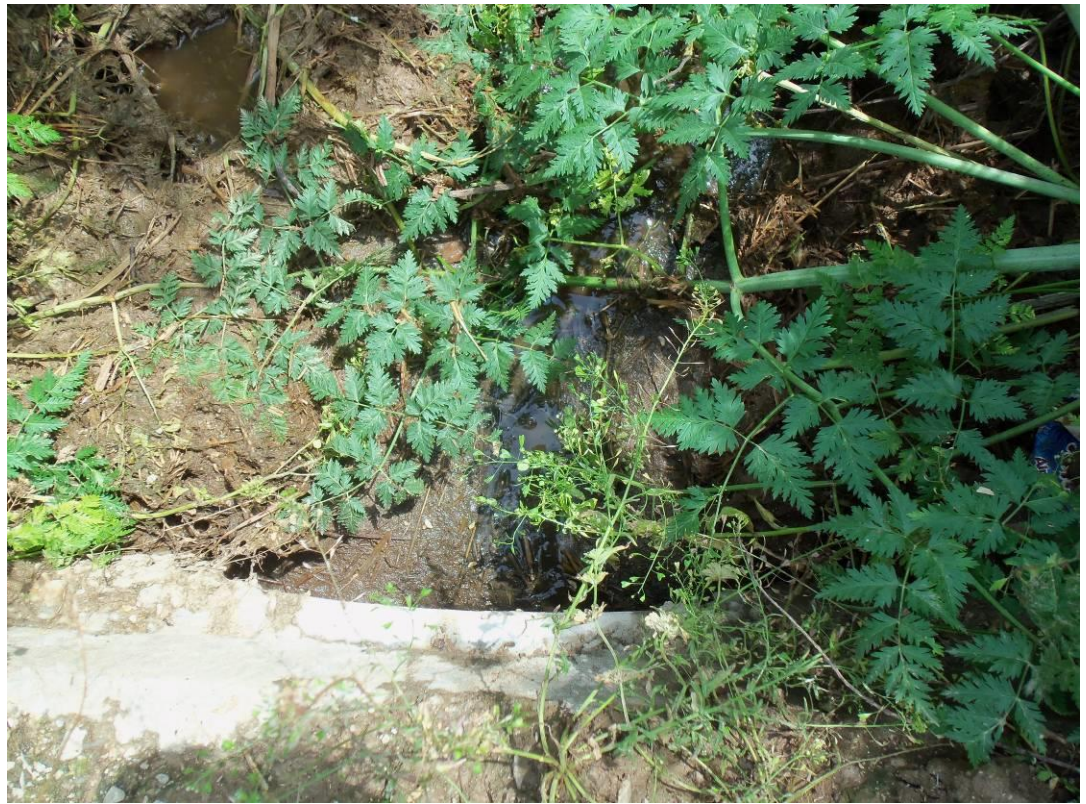
Photo # 006
Date: May 01, 2012
Time: 2:23 p.m.
Taken By: Brian Rodely DWPC/FOS
Facility: VB Family Farms
Location: Feedlot Runoff Culvert In
Notes: The culvert inlet of feedlot runoff described in Photo 005 is shown. Culvert discharges to the south in a ditch as shown in the site plan map.

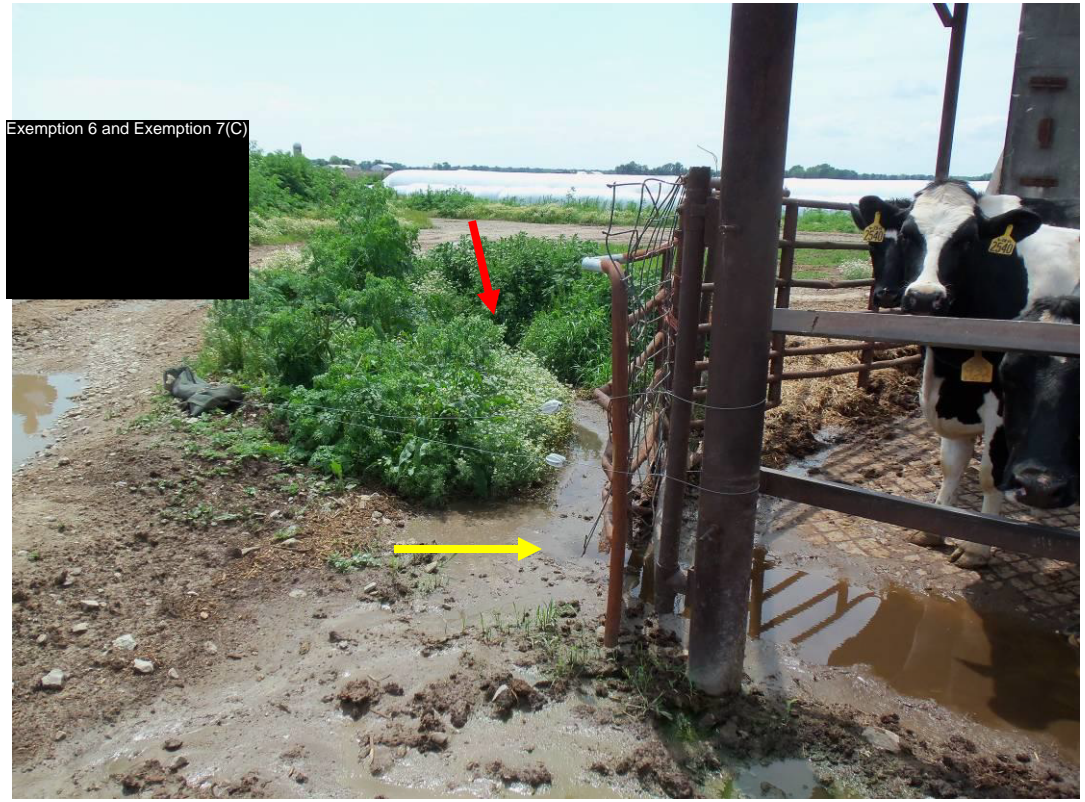
Photo # 007
Date: May 01, 2012
Time: 2:24 p.m.
Taken By: Brian Rodely DWPC/FOS
Facility: VB Family Farms
Location: E Feed Alley Face SW
Notes: Culvert described in Photo 005 and 006 has an inlet indicated by the red arrow. Manure laden feedlot runoff is noted with the yellow arrow running into the culvert.

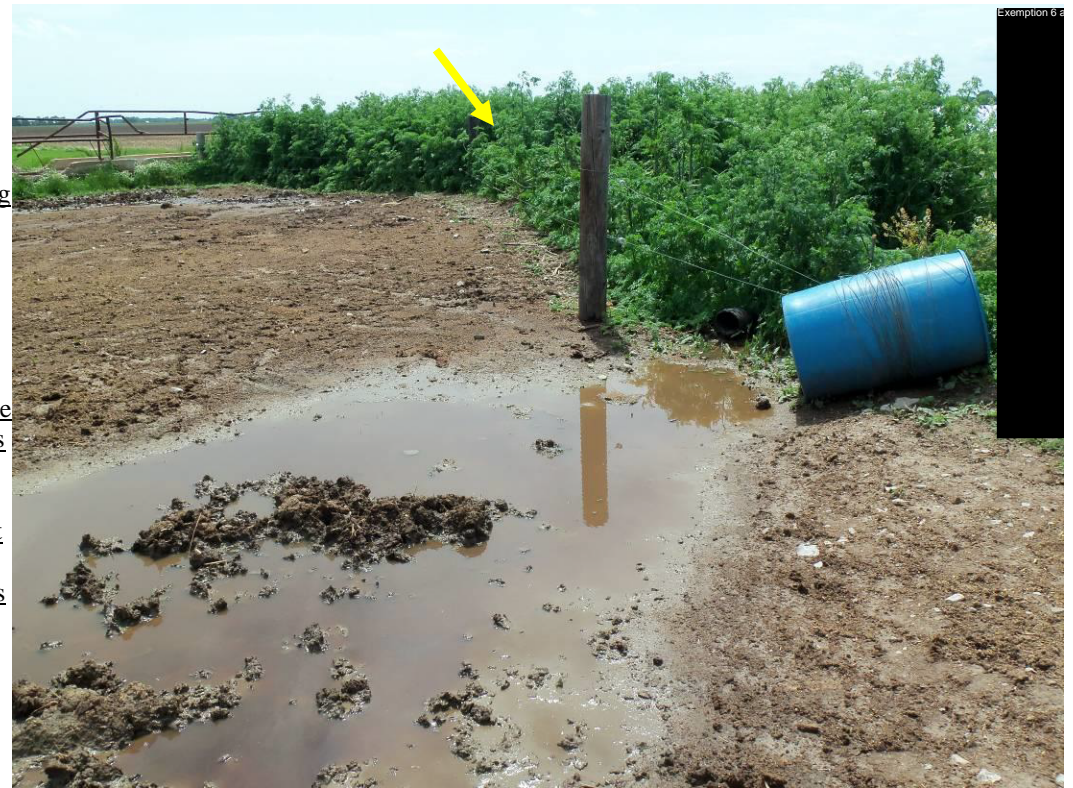
Photo # 008
Date: May 01, 2012
Time: 2:26 p.m.
Taken By: Brian Rodely DWPC/FOS
Facility: VB Family Farms
Location: W Free Stall Face SW
Notes: Runoff can be seen entering the ditch that receives discharge from the culvert described in Photos 005, 006, and 007. The black plastic drainage tile shown next to the blue barrel appeared to be a scrap piece of pipe and was not used as a discharge conduit. Wastewater drained south and entered another culvert where indicated by the yellow arrow that discharges south as shown in Photo 009.

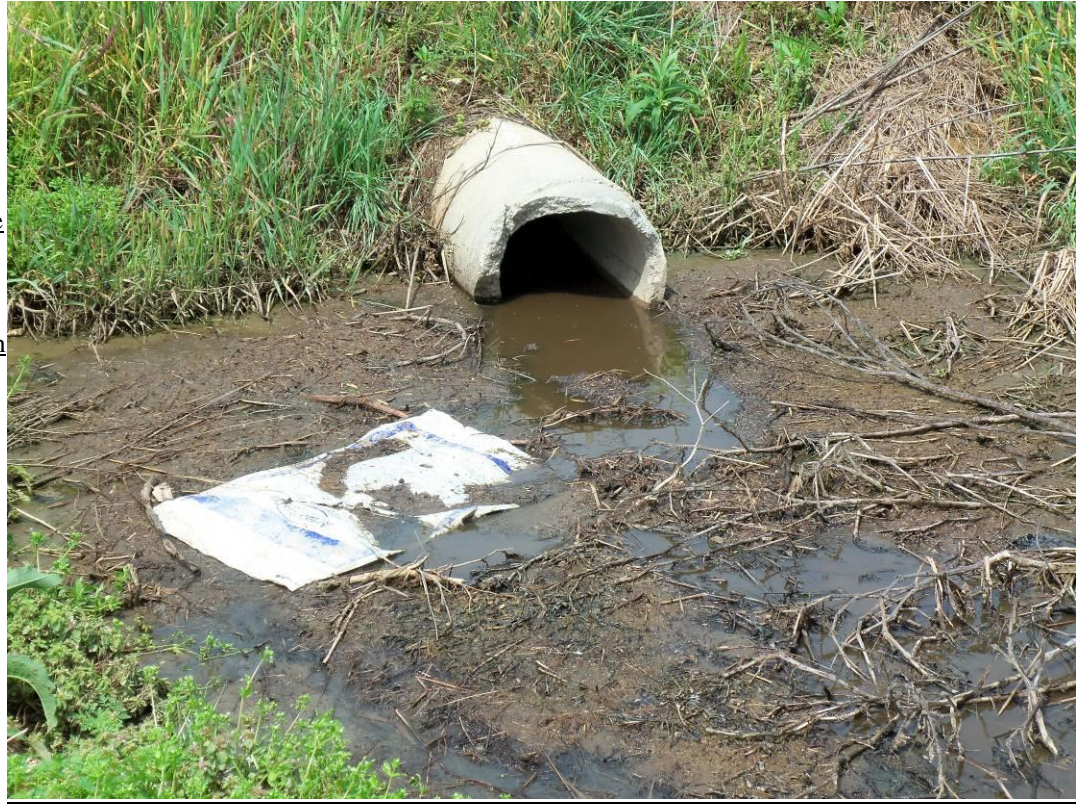
Photo # 009
Date: May 01, 2012
Time: 2:26 p.m.
Taken By: Brian Rodely DWPC/FOS
Facility: VB Family Farms
Location: S Silage Bunker Face N
Notes: Photo shows the outlet of the culvert used to drain the livestock waste south from the earthen feedlot, feed alley, and silage bunker. Wastewater continues south then crosses under a field road through a culvert as shown in Photo 010.

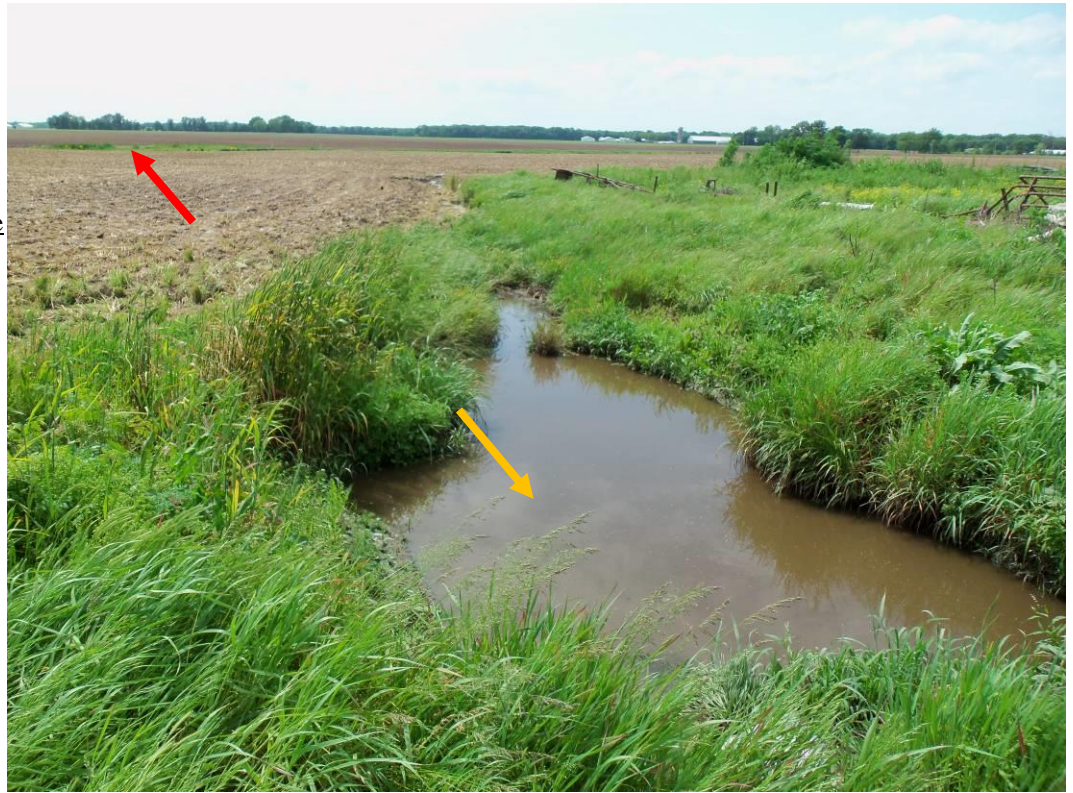
Photo # 010
Date: May 01, 2012
Time: 2:33 p.m.
Taken By: Brian Rodely DWPC/FOS
Facility: VB Family Farms
Location: S Silage Bunker Face W
Notes: Photo shows the outlet of the culvert used to drain the livestock waste westward under the field road. Wastewater runs across the field and reports to an unnamed tributary to Flat Branch as indicated by the red arrow. VB Family Farms sample was taken where indicated by the orange arrow.

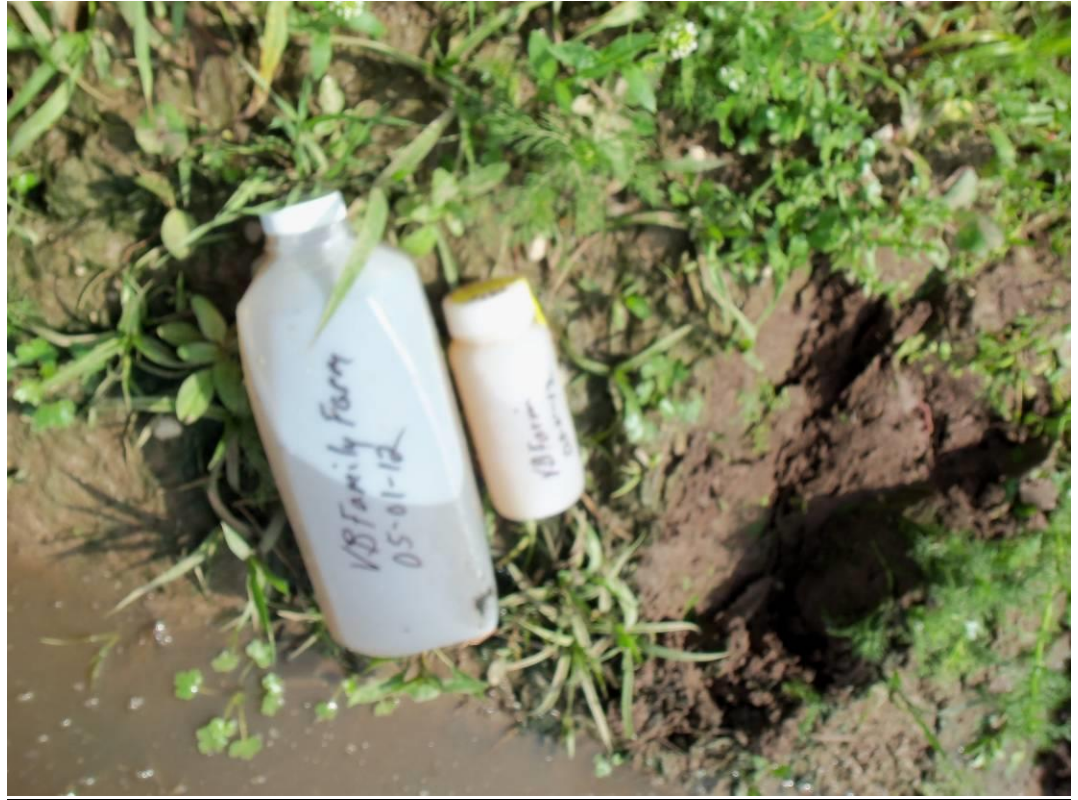
Photo # 011
Date: May 01, 2012
Time: 3:55 p.m.
Taken By: Brian Rodely DWPC/FOS
Facility: VB Family Farms
Location: Sampling Point W Culvert
Notes: Photo of sample collected
west of the east-west
discharge culvert.
